Monitoring Data Record

Project Title: NC 49 (R-2533B) COE Action ID: 1997702364  
 Stream Name: UT Cold Water Creek Site #20 DWQ Number: 011274  
 City, County and other Location Information: Cabarus County, Sta. 156+50 to Sta. 157+00 -L1-RT.  
 Date Construction Completed: April 15, 2005  
 Monitoring Year: ( 1 ) of 5  
 Ecoregion: \_\_\_\_\_ 8 digit HUC unit 03040105  
 USGS Quad Name and Coordinates: \_\_\_\_\_

# UT Cold Water Creek Site #20

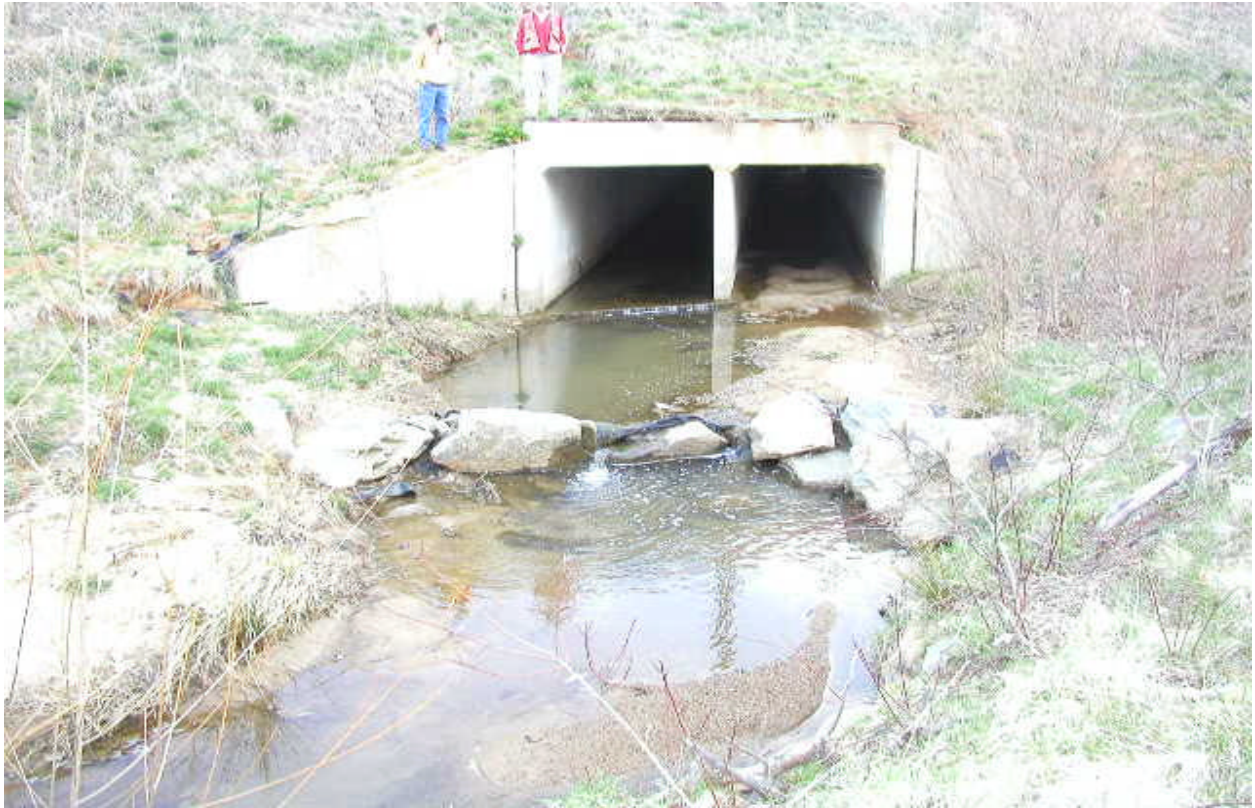
Photo #1 (Upstream)

This is the first year of monitoring at the UT to Cold Water Creek Site #20 stream relocation. The streambanks are stable throughout the stream relocation. An onsite meeting was held on March 8, 2007 with the Resource Agencies and NCDOT. It was agreed upon at this time that Site #20 could be closed out after one year of photo monitoring the stream relocation. Cross sections of the stream relocation were not required by the Resource Agencies. NCDOT has completed the one year of photo monitoring and proposes to discontinue stream stability monitoring at this site.
